Low Friction Coatings for Fuel Cells Compressors

O. O. Ajayi, G. R. Fenske, and A. Erdemir
Argonne National Laboratory
Argonne, IL 60439

DOE 2002 Review
OTT Fuel Cells Program

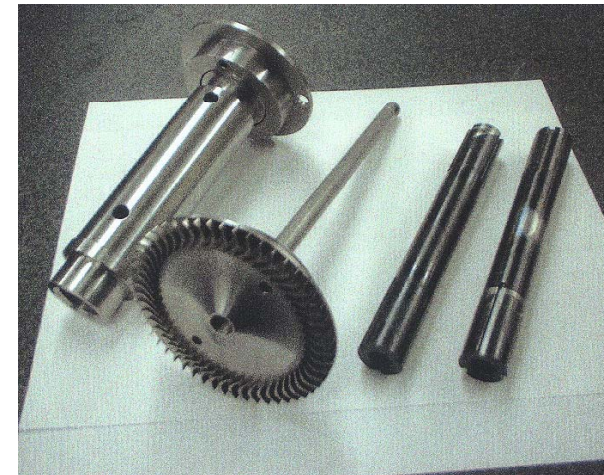
NFC Durability Testing

- Both Laboratory and initial air bearing rig tests showed NFC coating is needed for successful running of air bearing
 - Uncoated air bearing did not run - due to excessive wall climbing
- Durability of NFC coated rotor was evaluated by a start-stop cycles test protocol.
- Dimples were created coated bearing shaft surface to measure wear
 - Tests were interrupted at predetermine intervals and dimple dimensions measured. From change in dimple diameter linear wear on the coated surface can be calculated

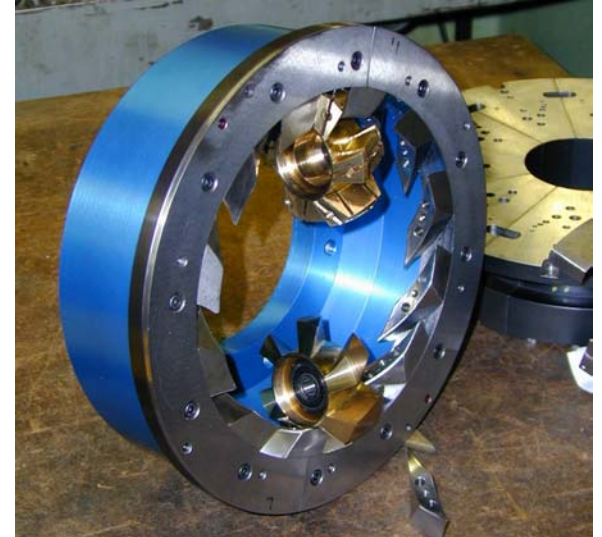
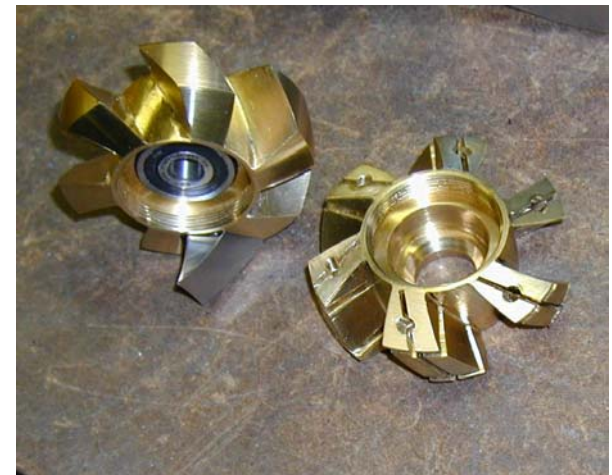
TIVM Frictional Sources

- To meet DOE compressor driver power target, overall friction coefficient in the TIVM must be less than 0.3
- The largest source of frictional loss is vane sliding interface; followed by compressor and expander bearings and the housing seal.
- In addition to low friction, the vane and seal surfaces must be wear resistant to meet the durability targets. They must also slide quietly to meet the noise target.

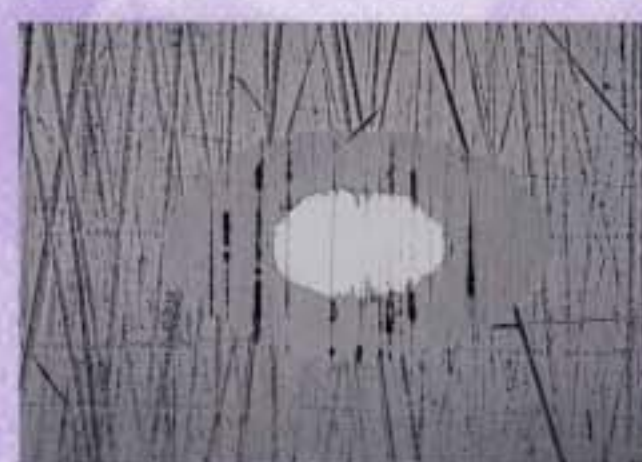
Dimple 1-9 after 250 cycles

Durability tests on NFC-coated air bearing rotor show linear wear typically stabilizes at $< 1.0 \mu\text{m}$. Greater wear on side 1 may be due to bearing imbalance. Bearing failed after 4,000 cycles (and later after 10,250 cycles) due to debris contamination.

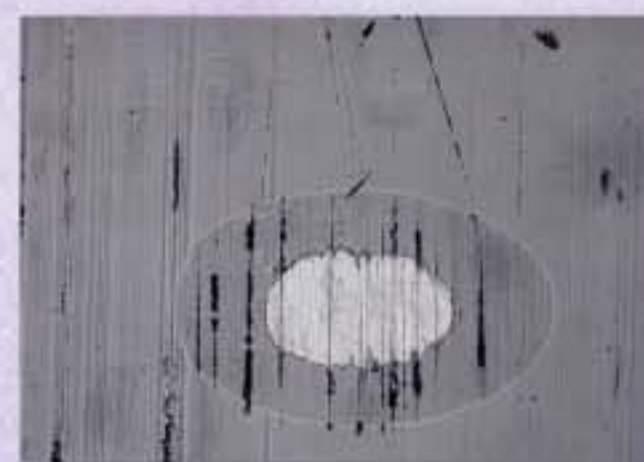
Dimple 1-9 after 4,000 cycles

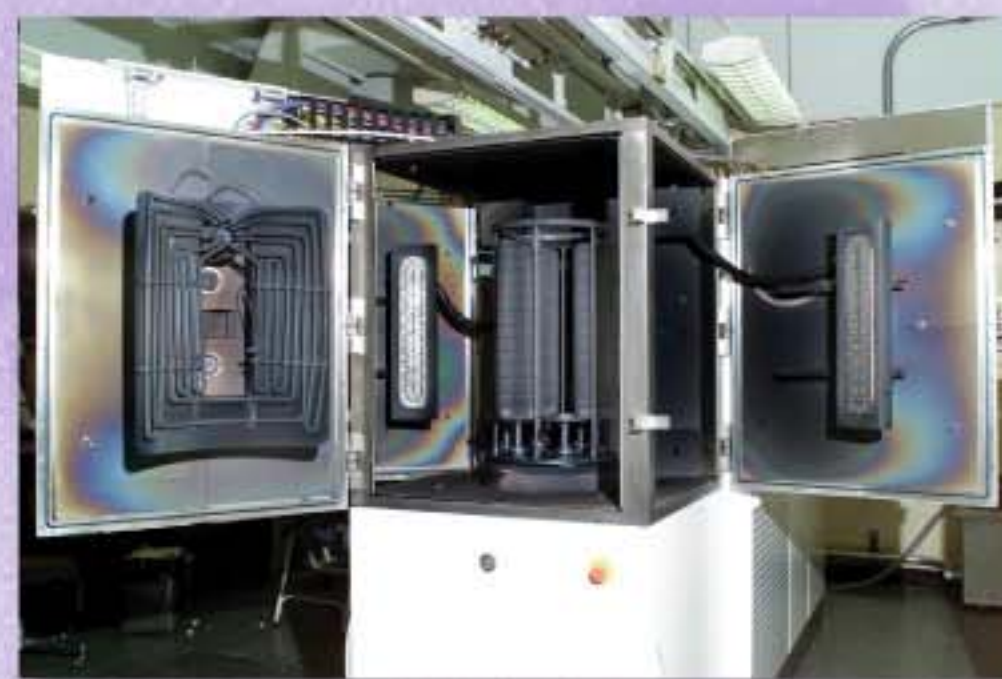
A commercial-scale, plasma-based NFC coating system is now fully operational.

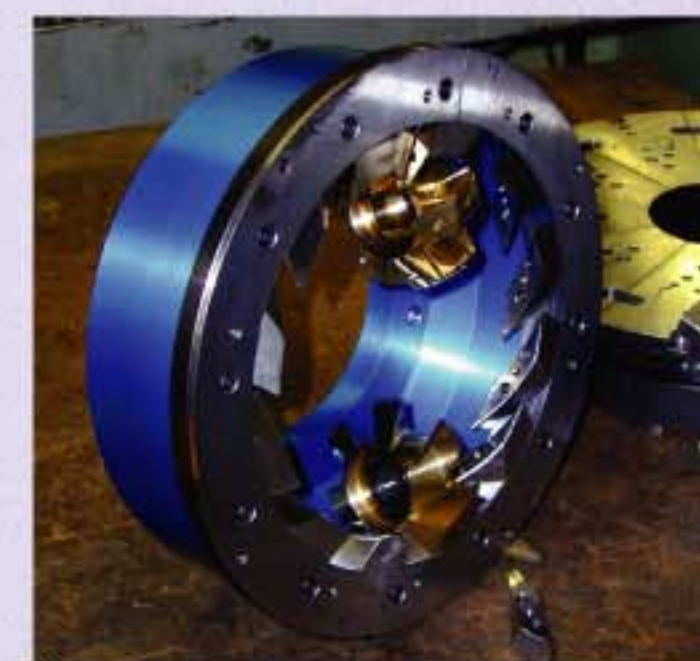
Toroidal intersecting vane machine (TIVM) components.
